NAVAL AIR ENGINEERING CENTER LAKEHURST NJ TEST DEPT
EVALUATION OF THE CVN 68/CVN 69 LAUNCHING SYSTEM.(U)
DEC 77 M A MANGANELLO
NAEC-94-1140

NAEC-94-1140

6
EVALUATION OF THE CVN 68/CVN 69
LAUNCHING SYSTEM

10 Michael A. Manganello

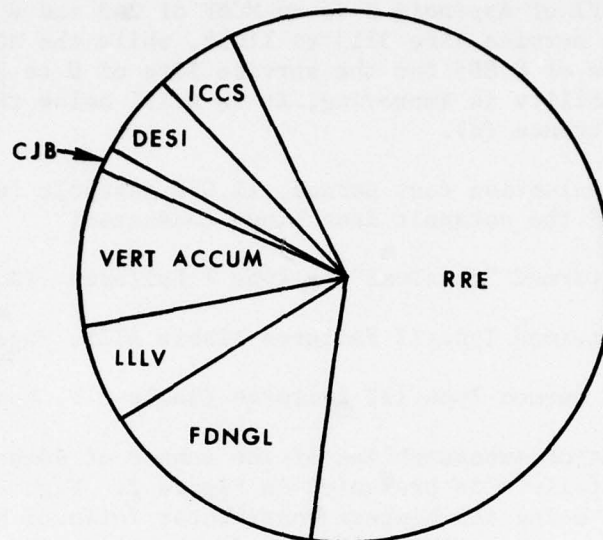
FIGURE 3 - BREAKDOWN OF 64 TYPE I FAILURES
ACCORDING TO EACH SUBSYSTEM

With respect to "critical" or Type I failures, Figure 3 on the following page clearly shows the RRE as the single largest contributor.

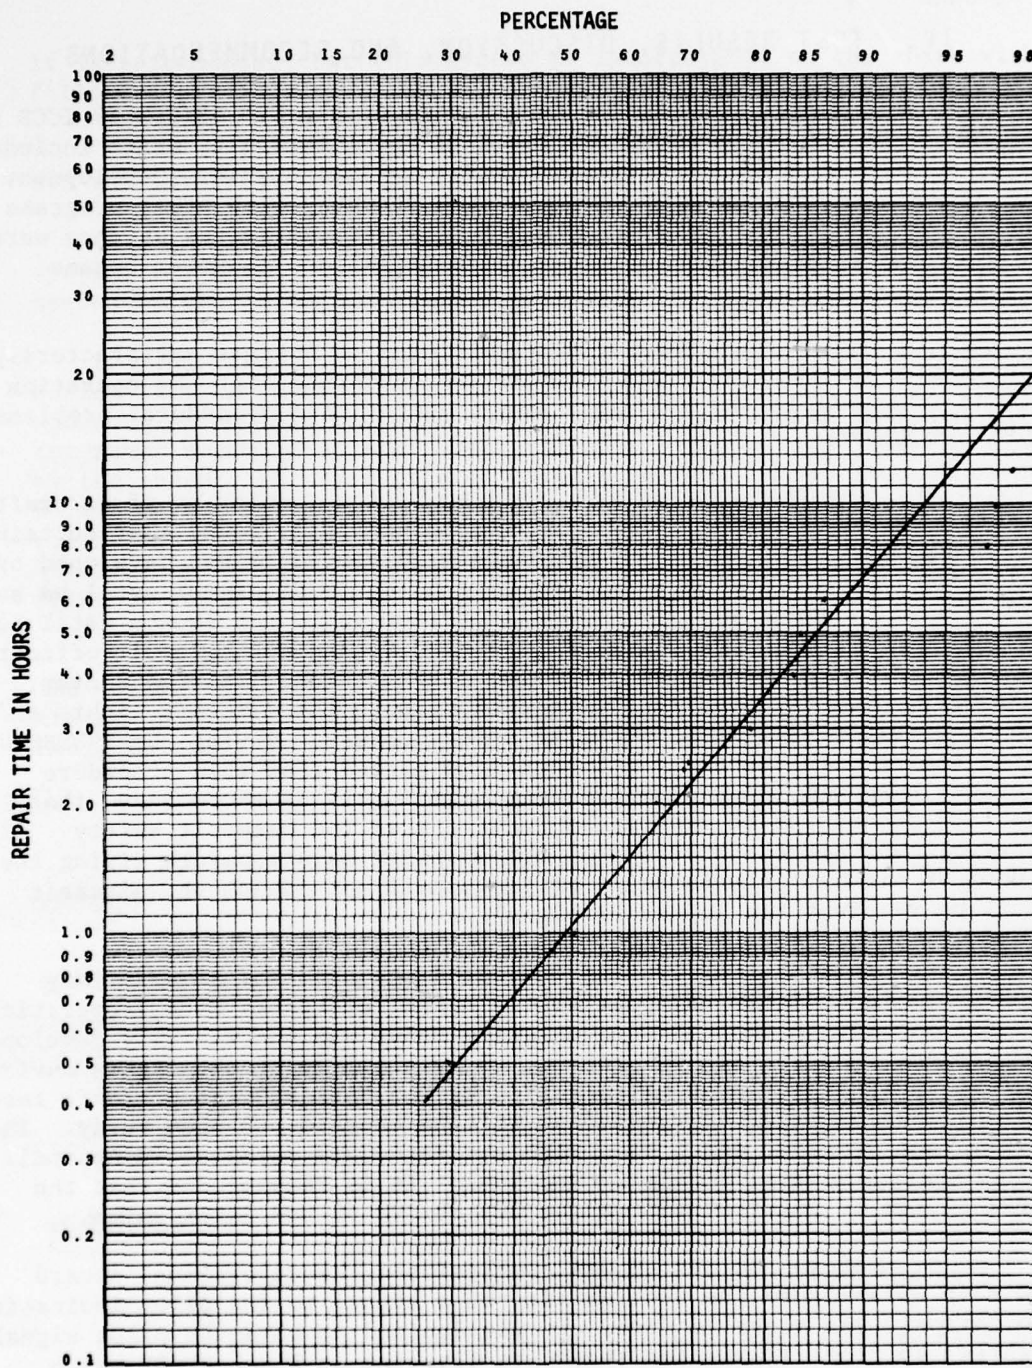
FIGURE 4 - PROBABILITY OF REPAIR (PERCENTAGE)

E. The NAVAIRENGCEN Test Department has established that the maintainability, expressed as the probability of repair in a given time, for the CVN 68/CVN 69 launching system shall be that 84 percent of all the repair actions will be accomplished in less than one hour. Figure 4 on the following page illustrates that of the 263 total corrective maintenance actions, only 50 percent were accomplished in one hour or less. This is far below the established goal. The MTTR of the CVN 68/CVN 69 launching system components was determined to be 3.05 hours.
